# **OMAP4430 Multimedia Device Silicon Errata Silicon Revision 2.3, 2.2, 2.1, 2.0**

**Texas Instruments OMAP™ Family of Products**

**Version Q**

## **Errata**

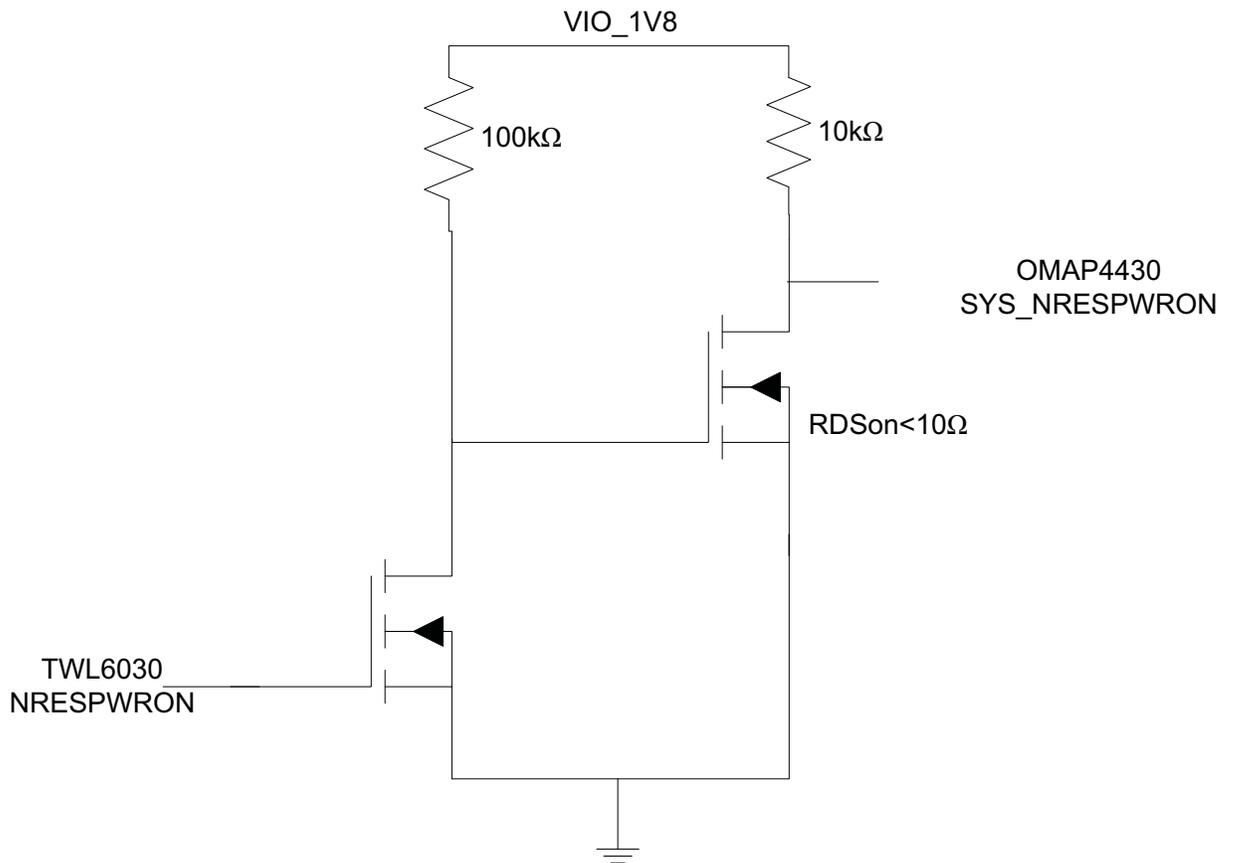
**Figure 1-1. Buffer Implementation**

During OMAP4430 platform power up, the power-on reset input signal for OMAP4430 is mistakenly driven by itself. It can cause some unexpected level on OMAP output pins which are supposed to stay in their default voltage value.

Board can so fail to boot because:

- It is impossible to ensure correct operation of the I/Os used to control external ICs involved in board power management (supply power path, battery charger circuits, etc).
- Inrush current during power supply ramp can be higher than expected and can cause the battery voltage to drop down.

As a hardware workaround, some components must be placed on board to ensure the voltage at OMAP4430 SYS\_NRESPWRON is kept below 0.5V while TWL6030 is driving low state. One example is shown in following schematic.

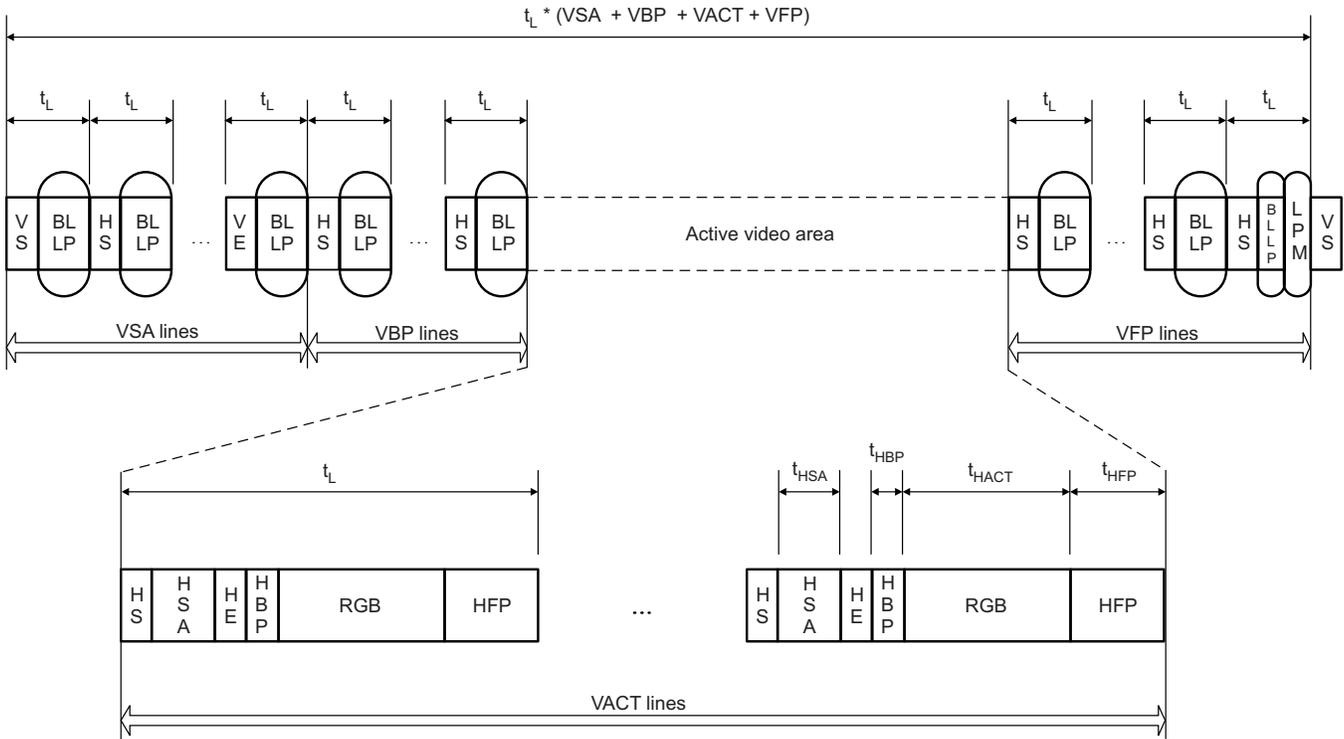
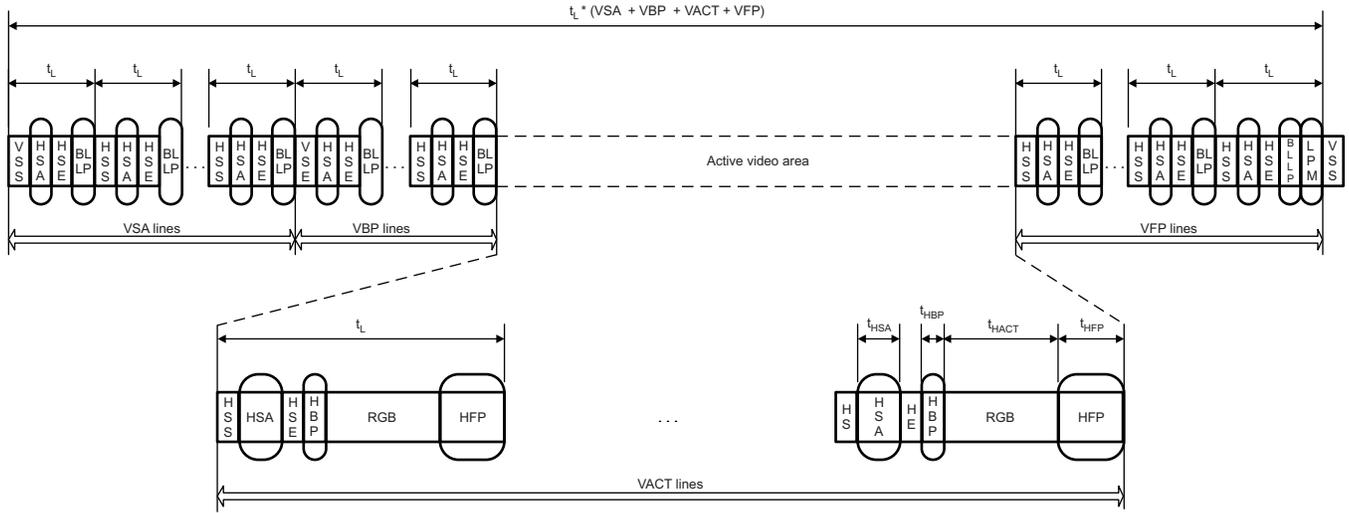
- The DSI protocol engine sends only HE packets (when enabled) during VACT and not during VSA, VFP, and VBP.
- The DSI protocol engine sends VE (noted as VSE in MIPI DSI ver. 1.01 specification) during VSA and not during VBP.

Figure 2.1 represents actual implementation and Figure 2.2 represents MIPI DSI ver. 1.01 specification.

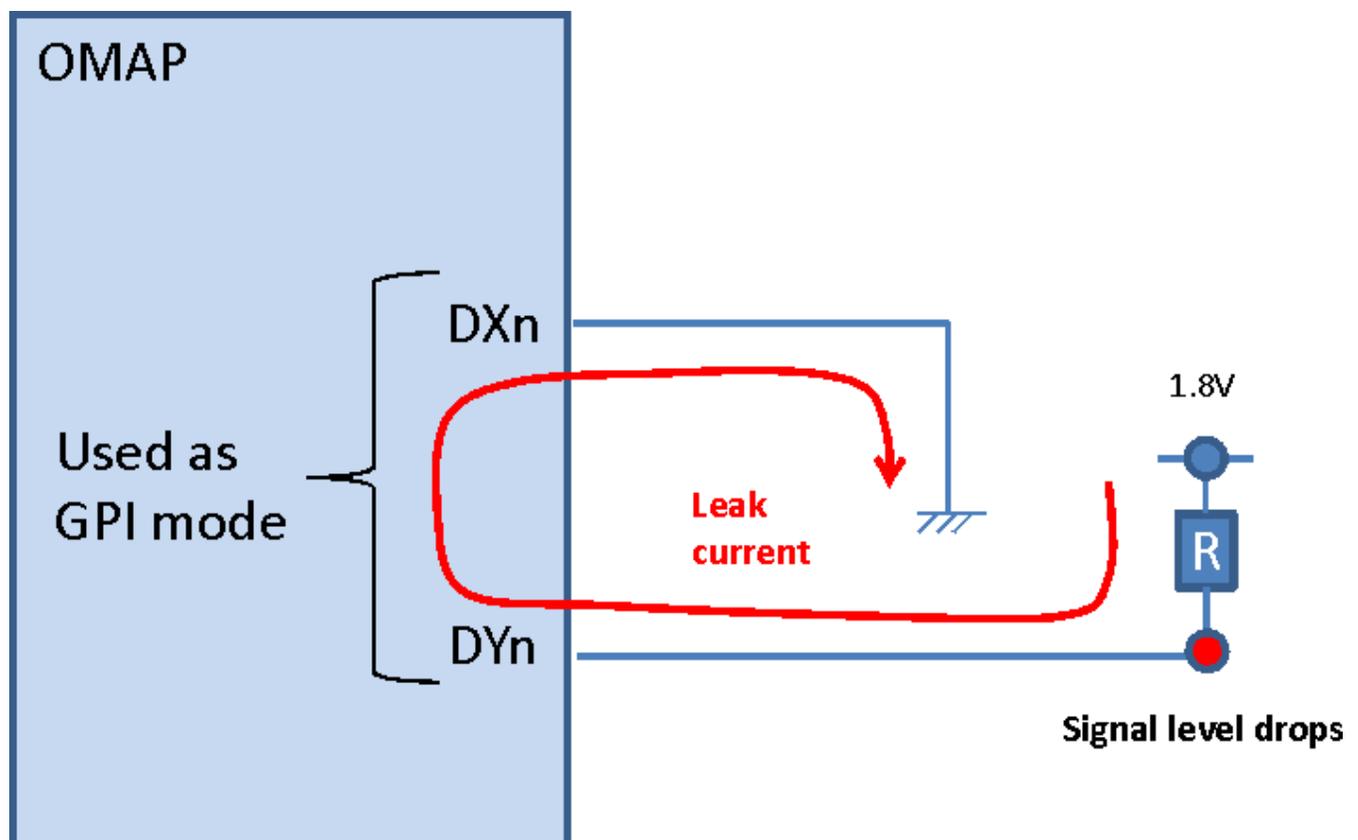
Figure 2-3. CSI PHY pad in GPI mode

The signal level of the pad which is pulled-up is dropped due to the leakage of the component used in the off switch for the on-die termination between DXn and DYn. The leakage current (and the voltage drop) varies depending on PVT condition.

Under the worst case condition, the leakage can be high enough to drop the signal level under VIH of the GPI buffer and causes functional failure.

1. Use different pad for GPI.
2. Use the pull-up resistor value smaller than or equal to 9k Ohm. It avoids the voltage drop and keeps the signal level above VIH. However this will be at the expense of increased current (up to 70uA in the worst case), as long as DXn and DYn are opposite in polarity.

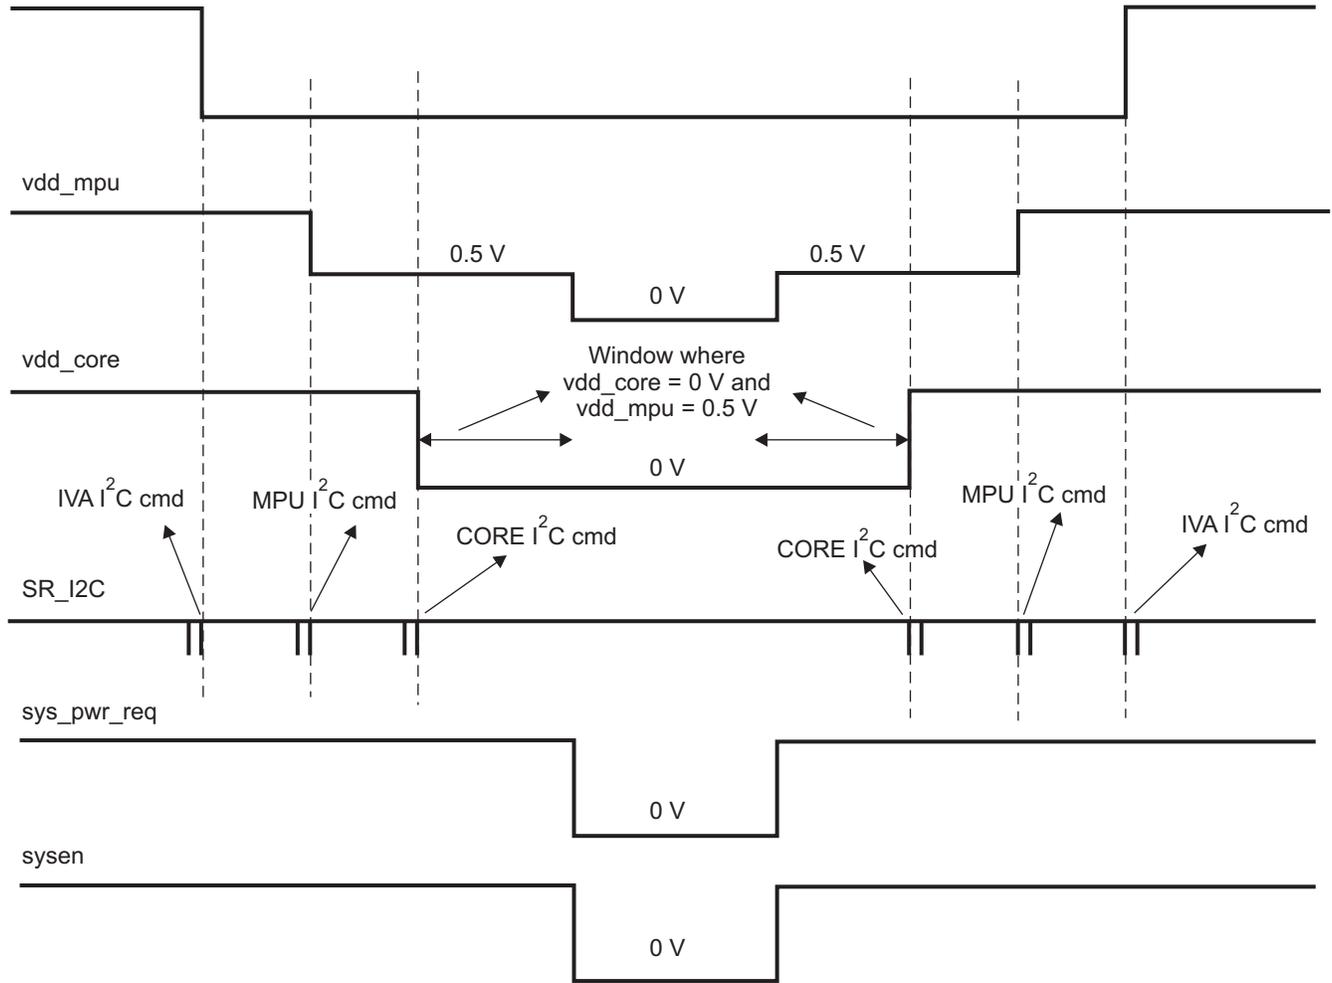
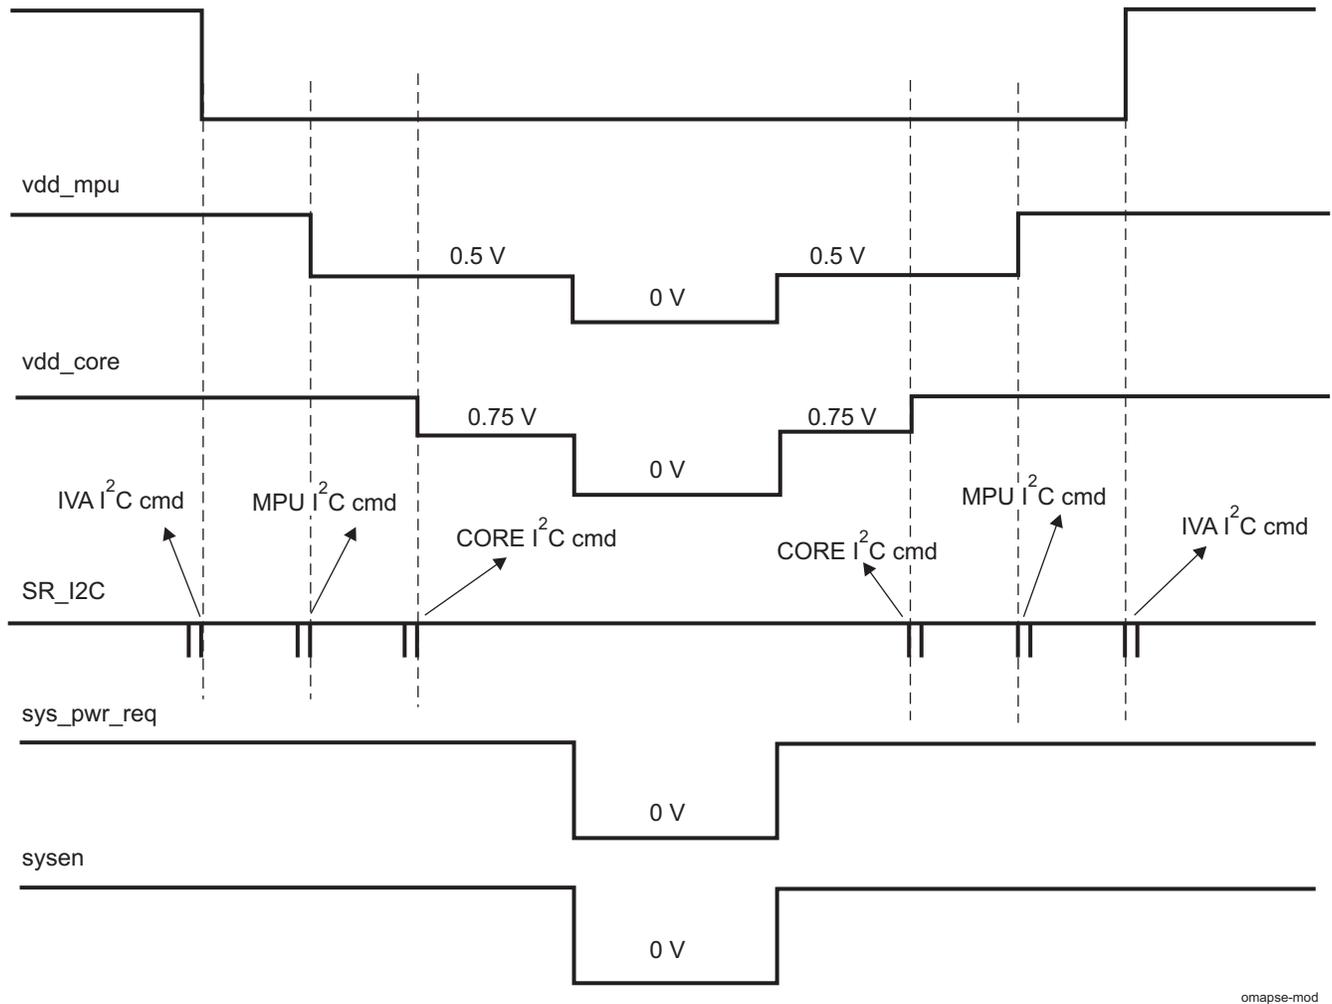
The original OMAP44xx OFF-wakeup sequence without the Guidelines is shown below.

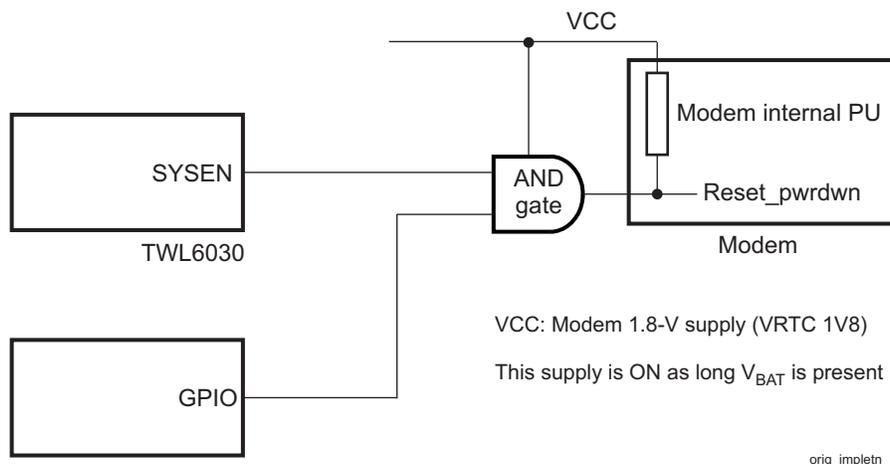
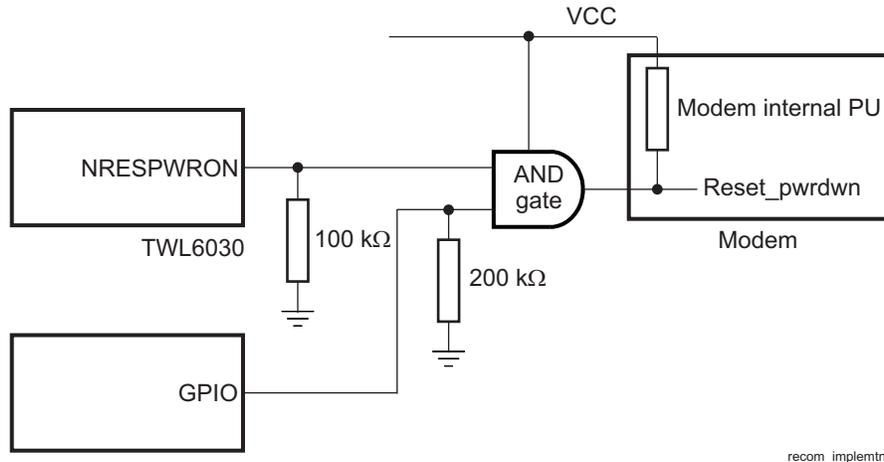
The figure below shows the modem.
